DEPARTMENT OF TRANSPORTATION

Quality Assurance and Source Inspection

WELDING INSPECTION REPORT

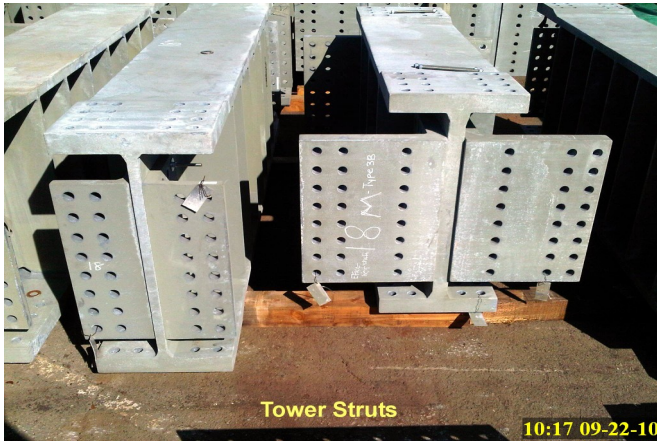
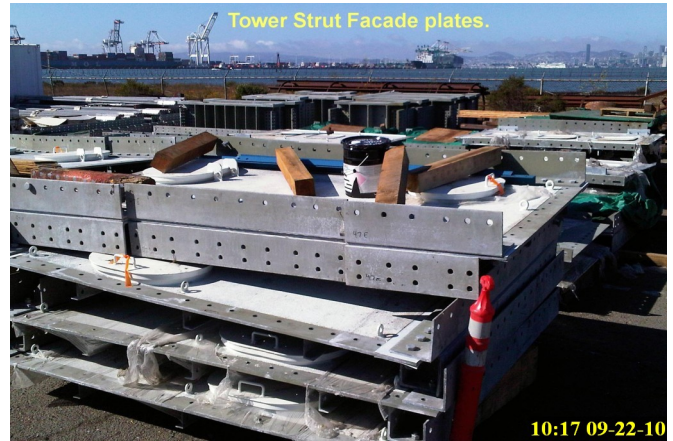
The QAI accompanied the QAI Robert Mertz, the Structural Materials Representative (SMR) Jason Lee and ABF representative Chuck Kanapicki in conducting the post arrival inspection of voyage 3 and 4 components. During the inspection, the QAI noted that painted surfaces have been marred from general shipping and handling. There was no other shipping related damage observed during this inspection. The QAI noted that parts examined include tower struts, strut facades, diaphragm and ring beam components. The QAI noted that spare components are in storage and according to ABF representative Chuck Kanapicki, the parts in the storage yard were examined by

Sanny Khow. The QAI noted that at this time, all major components of Voyage 3 & 4 have been examined for post arrival inspection. See the attached photos.
